**ASCE Specialty Conference on Vertical and Horizontal  
Deformations of Foundations and Embankments  
at Texas A&M University, College Station, Texas,  
June 16, 17, and 18, 1994**

**COMPACTION GROUTING STOPS SETTLEMENT OF  
AN OPERATING WATER TREATMENT PLANT**

**Percy M. Wimberly, III,<sup>1</sup> Member ASCE, F. Barry Newman,<sup>2</sup>  
Member, ASCE, Kenneth B. Andromalos,<sup>3</sup> Member, ASCE, and  
Chris R. Ryan,<sup>4</sup> Member, ASCE**

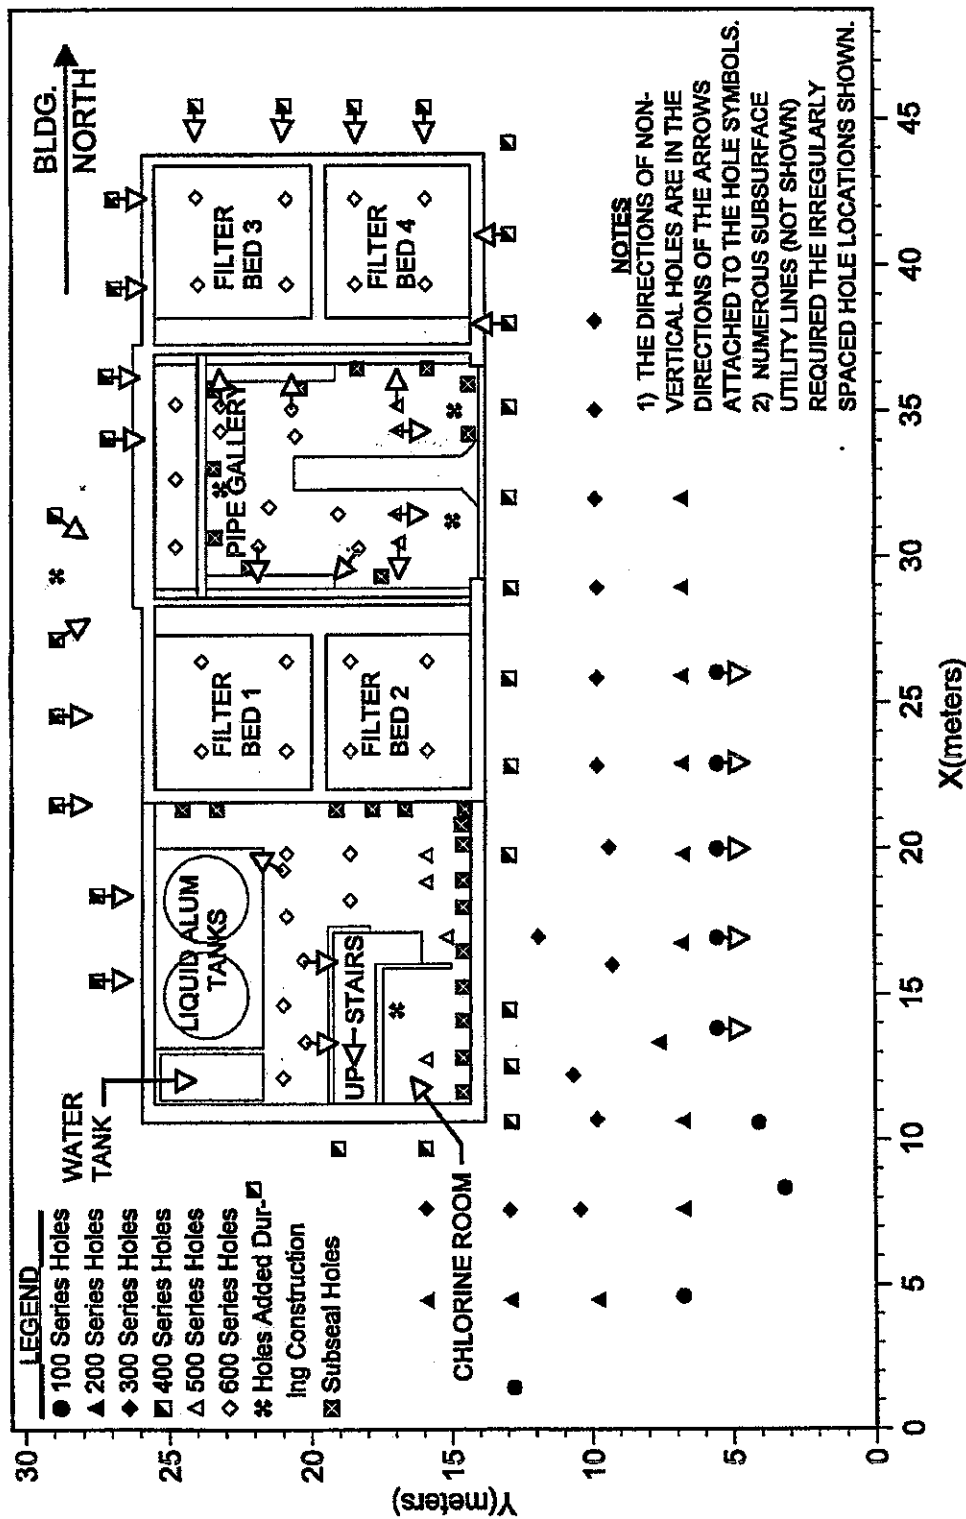
FIG. 1. Plan of Compaction Grouting Holes and Subseal Holes

The Red Mountain Water Treatment Facility's filter plant building is a rectangular, 2-story, precast and cast-in-place concrete structure, about 11.9 m wide by 33.1 m long. The building houses 4 filter beds, a pipe gallery, an office area, and a chemical storage area. The filter beds and pipe gallery are located in the northern (plant north) two-thirds of the building with the pipe gallery separating the 2 pairs of filters. The filter bed and pipe gallery are cast-in-place reinforced concrete. The southern end of the building contains the chemical storage areas and the second floor office. The building walls are comprised of vertical precast concrete panels, while the roof is comprised of horizontal precast concrete panels spanning east-west, which supports a built-up roof. The general plan of the building is shown on Fig.1.

In performing the compaction grouting work, voids were detected below the concrete in the building area. Soundings were done and 25 holes were cored through the concrete to permit high slump ( $30.48 \pm$  cm) grout to be injected to fill (seal) the subsurface voids. These hole locations are shown on Fig. 1 as subseal holes. Little to no take occurred in the Pipe and Valve Gallery area. Along the south side of Filter Beds 1 and 2, voids about 2.5 cm deep were grouted. Along the east wall south of Filter Bed 2, a 7.6 to 10.2 cm deep void was grouted for about the northern half. The void depth tapered to about 2.5 cm near the southeast corner. About 2 m<sup>3</sup> of subseal grout were injected to fill the voids.

drilling on the steep Backwash Pond 1 slope), 200 Series (12 holes vertical), 300 Series (14 holes vertical), 400 Series (13 holes vertical and 16 angled to avoid buried utilities). The inside holes were then drilled and grouted in the following general order: 500 Series (4 holes vertical and 4 angled) and 600 Series (30 holes vertical and 6 angled). Due to hole relocations and wide spacings in certain areas, 4 vertical inside holes were added during construction. One outside vertical hole was added on the west side of the building, where the 3 nearby holes had relatively high grout takes to the bottom of the holes.

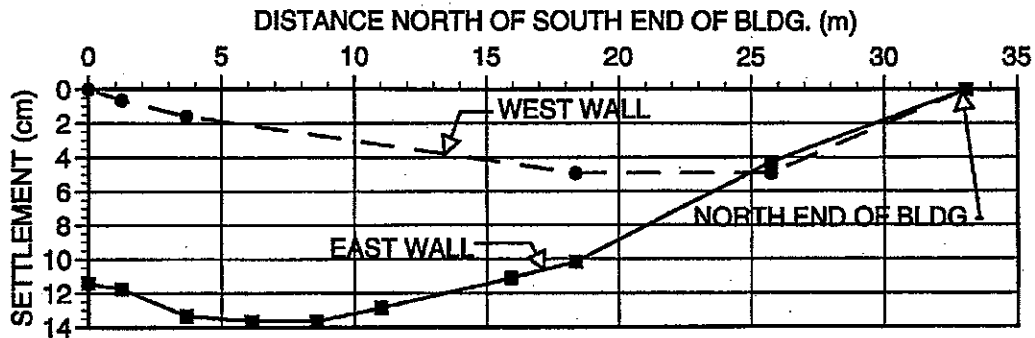
FIG. 2. Settlement of East and West Walls in Mid-1986

Settlement profiles of the east and west walls of the building as of mid-1986, prior to remedial work, are shown in Fig. 2. The differential settlements were observable in the form of displacements and cracks in the building.

It was noted by plotting top of rock profiles along the east and west walls of the filter plant building that the shapes of the plotted profiles were similar to those of the building settlement profiles along the east and west walls shown on Fig. 2. This suggested that the full soil depth above the top of rock was settling.

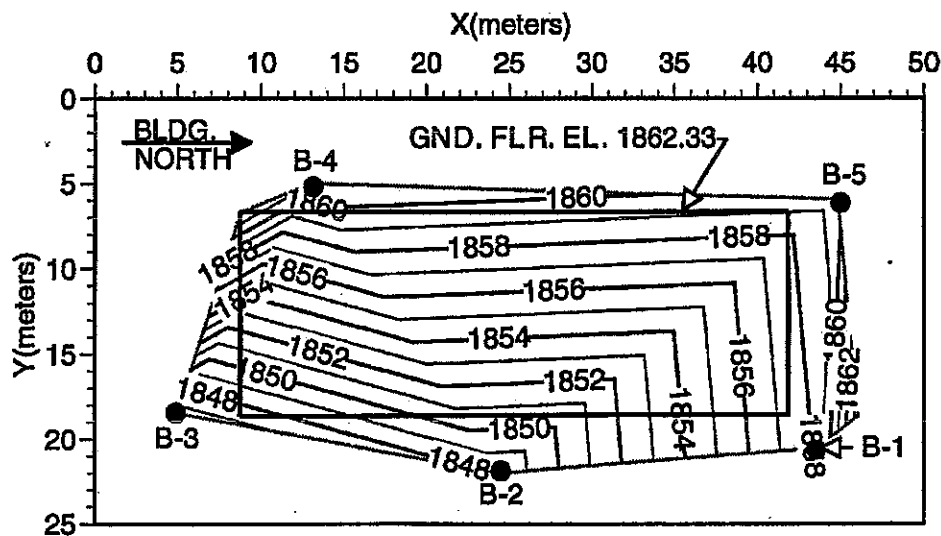
FIG. 3. Plan of Borings and Estimated Top of Rock Elevations in Meters

Due to differences in soil depths presumed to be involved in the settling presented by earlier consultants, an additional geotechnical investigation was performed by GAI to better define the problem. Five borings were drilled in early March 1987 at the locations shown on Fig. 3. Borings B-1 through B-5 were drilled to depths of 32.0, 36.6, 36.6, 14.6, and 13.7 m, respectively. Continuous standard penetration testing was done in soil, followed by cleaning out of the holes between samples using 15.9 cm O.D. hollow-stem augers, except where boulders were encountered and the augers were used to penetrate the boulders before resuming sampling. Two 6.35 cm O.D. Shelby tube samples were attempted in an auger hole near Boring B-2 between depths of 3.35 to 3.66 m and 7.32 to 7.68 m. Both tubes suffered rock induced deformation, poor recovery, and high sample disturbance. Pocket penetrometer readings of undrained shear strength were obtained for some of the cohesive soil samples. In general, continuous "NQ" rock core samples were obtained when soil sampling met refusal. Drilling mud was used during coring to maintain an open hole and remove cuttings. Special techniques, such as the use of short core runs, a split inner core barrel to aid in core removal, etc., were used to obtain and preserve the rather delicate rock types encountered during coring. Coring began in Borings B-1 through B-5 at depths of 5.6, 14.0, 13.7, 5.3, and 4.2 m, respectively. Soil depths in Borings B-1 through B-5 were estimated to be 4.9, 13.7, 15.6, 4.6, and 3.9 m, respectively. These depths to rock agree roughly with those of the earlier fall 1978 study. The top of rock contours estimated in the area of the filter plant building and shown on Fig. 3 are generally based on the 5 borings and the visible rock outcrops near the building of the 1987 investigation. Top of angles, clay seams, etc. were recorded for the recovered core. Perforated PVC pipe of 5.1 cm I.D. was inserted to or below the top of rock in Borings B-1, B-3, B-4, and B-5 to permit ground-water level monitoring following drilling. In general, rock information from earlier borings near the building was given less consideration in developing the top of rock contours shown on Fig. 3, since in cases the earlier data conflicted with that of the 1987 investigation. Core recovery, RQD, fracture some flushing of the holes using a garden hose and water was required to remove caved plugs and permit the insertion of the PVC pipe to the desired depths. Boring B-2 was reamed to about 15.2 cm I.D., and unperforated 8.6 cm O.D. aluminum

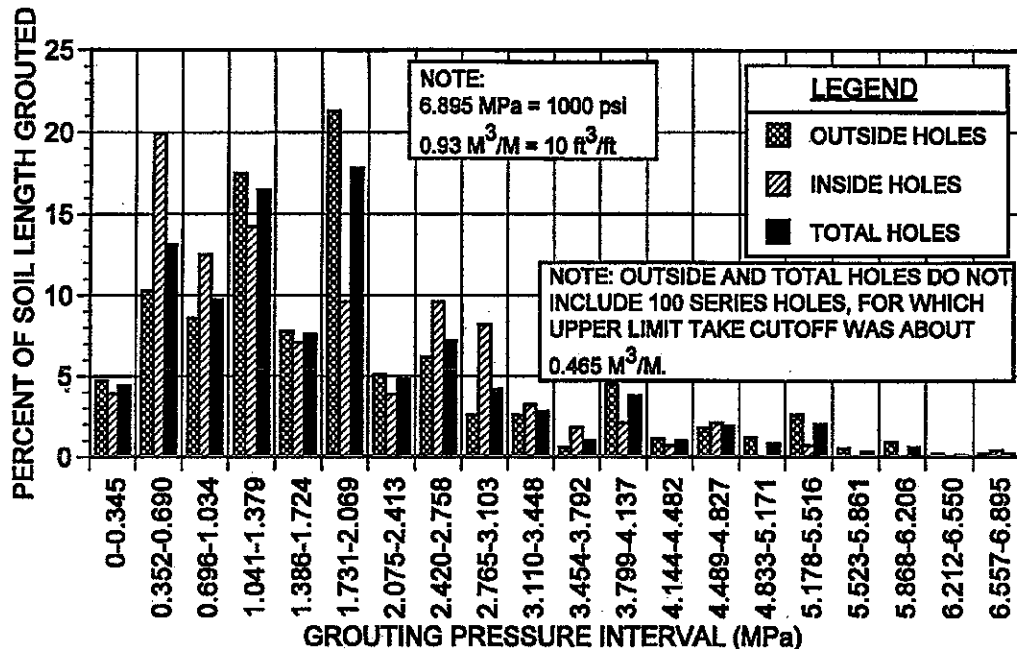
FIG. 4. Percent of Soil Length Grouted When Take  $\geq 0.93 \text{ m}^3/\text{m}$  versus Grouting Pressure Interval

Table 3 summarizes the grout take data in soil. The data in Table 3 indicate that the soil was generally looser or softer in the region outside of the building than it was below the building. This may be partly due to one or more of: (1) The settlement which had occurred under the building; (2) Better initial near-surface compaction in the area of the building than elsewhere; and (3) The earlier grouting and remedial work below the building. Fig. 4 shows a plot of the percent of the soil length grouted for outside, inside, and total holes that were controlled by the upper grout take limit versus the pressure interval occurring during injection when the upper take limit was reached. In general, most of the upper limit takes occurred

under relative low grouting pressures, below about 30 percent of the upper pressure limit.
