Use of a Reinforced Jet Grout Excavation Support System for a Major Sewer Line Repair

Eric M. Klein, P. E., Rummel, Klepper & Kahl, LLP, Baltimore, Maryland
Kenneth B. Andromalos, P. E., Geo-Solutions, Inc., New Kensington, PA
Richard Brink, P. E., KCI Technologies, Inc., Baltimore, Maryland

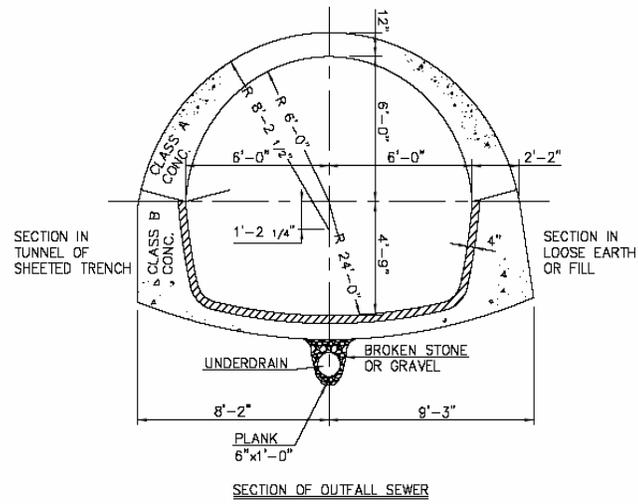
Figure 2 Cross Section of Existing Main Outfall Sewer

cross section, and is constructed from unreinforced cast-in-place (CIP) concrete with brick lining in the lower half. The wall thickness ranges from 12-inches at the crown and the invert to 26-inches at the sidewalls. The cross section of the existing pipes, derived from the original construction plans is shown in Figure 2. It is thought that this portion of the outfall was built using cut and cover techniques. The crown of the Main Outfall Sewer is located about 22 feet below the existing ground surface. The typical flow through the outfall is 140 million gallons per day (MGD) with a peak flow of 223 MGD. There were no possibilities of diverting flow to other bypass systems as no such bypass systems exist.

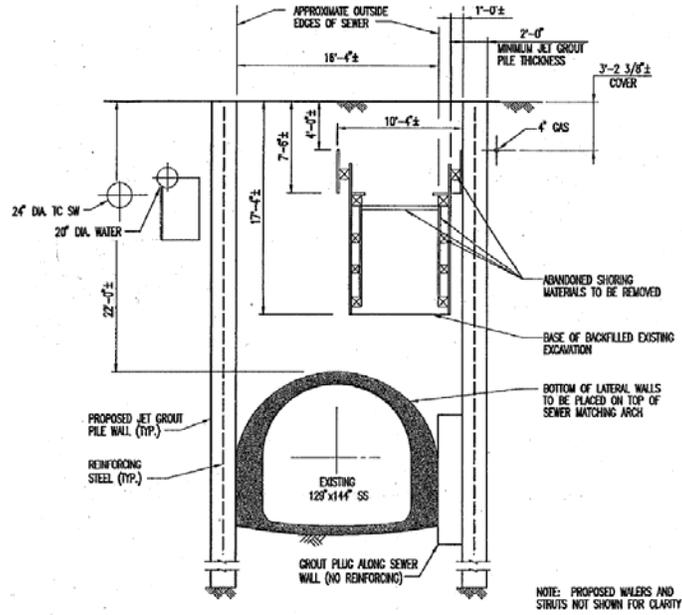
Figure 3 Cross Section of Excavation

The soil beneath the water main was to be stabilized with jet grout under-pinning as an additional safety precaution. Steel pipe or rebar was to be used for the reinforcement in the center of each grout column. Steel wide flange members used as walers and struts were provided at three levels to within one-foot of the top of the existing Main Outfall Sewer. The cross section and plan of the excavation support system are shown in Figures 3 and 4, respectively. The wales and struts are not shown in these figures for clarity.

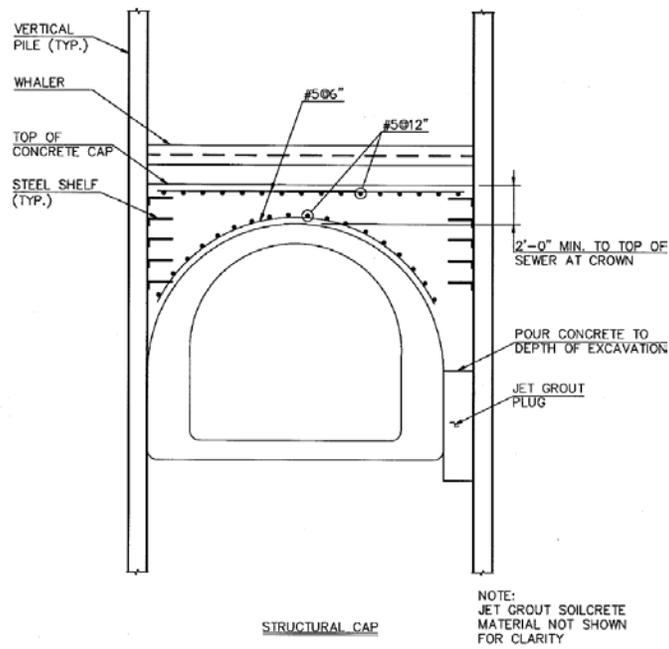
Figure 5 Cross Section of Structural Cap

The excavation proceeded well and successfully exposed the top of the Main Outfall Sewer. While no hole through the conduit was found, a condition inspection at the top of the Main Outfall Sewer found the concrete to be soft with no sound concrete located after digging into it several inches. It was possible to remove concrete from the Main Outfall Sewer with a garden hose and with minimal effort using hands and hand tools.

It was decided that the entire roof of the Main Outfall Sewer should be replaced. It was not possible to remove the existing roof without causing significant environmental effects to the residents and the workers. Therefore, a reinforced concrete cap was cast over the sewer. The existing roof would be used as the lower portion of the form to cast the new

concrete roof. While it was thought that friction between the concrete roof and the jet grout walls would be able to support the cap, for redundancy, steel shear connectors were welded to the steel wide flange members. The cross section of the structural cap is shown in Figure 5. On May 14, 2003, the structural cap was designed and forwarded to the contractor.

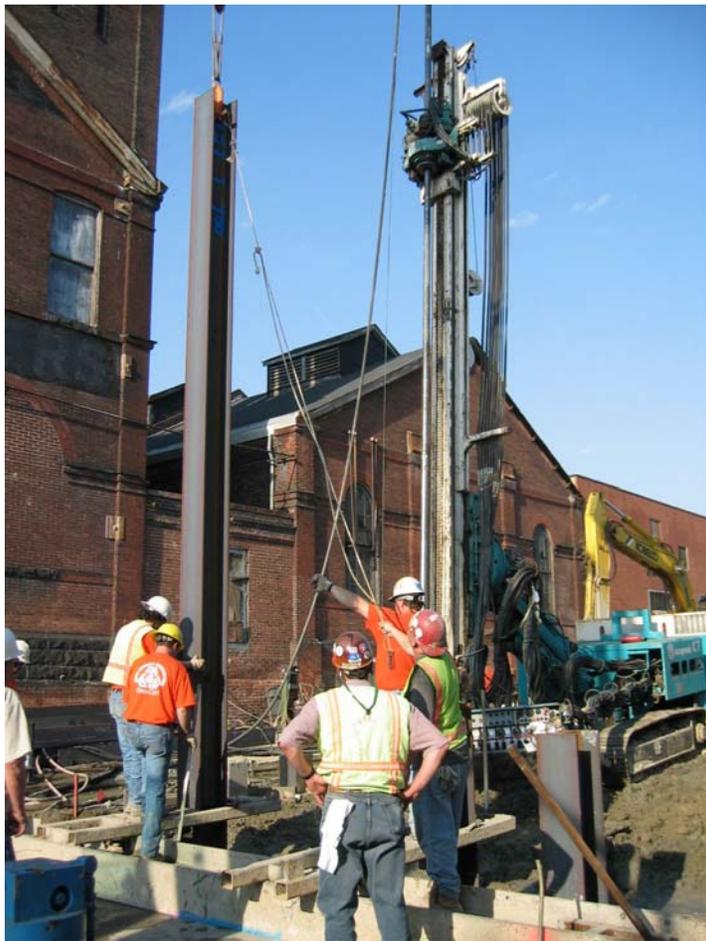
Figure 6 Placing steel in the west wall of the excavation

Extreme care was exercised during drilling of the jet grout columns over the Main Outfall Sewer. Drilling pressure and speed were reduced when it was thought that the grout monitor was getting close to the Main Outfall Sewer. Depth of refusal at each location was plotted so that depth of refusal could be predicted. Figure 6 shows the templates suspending the steel members over the conduit and the placement of another steel member.

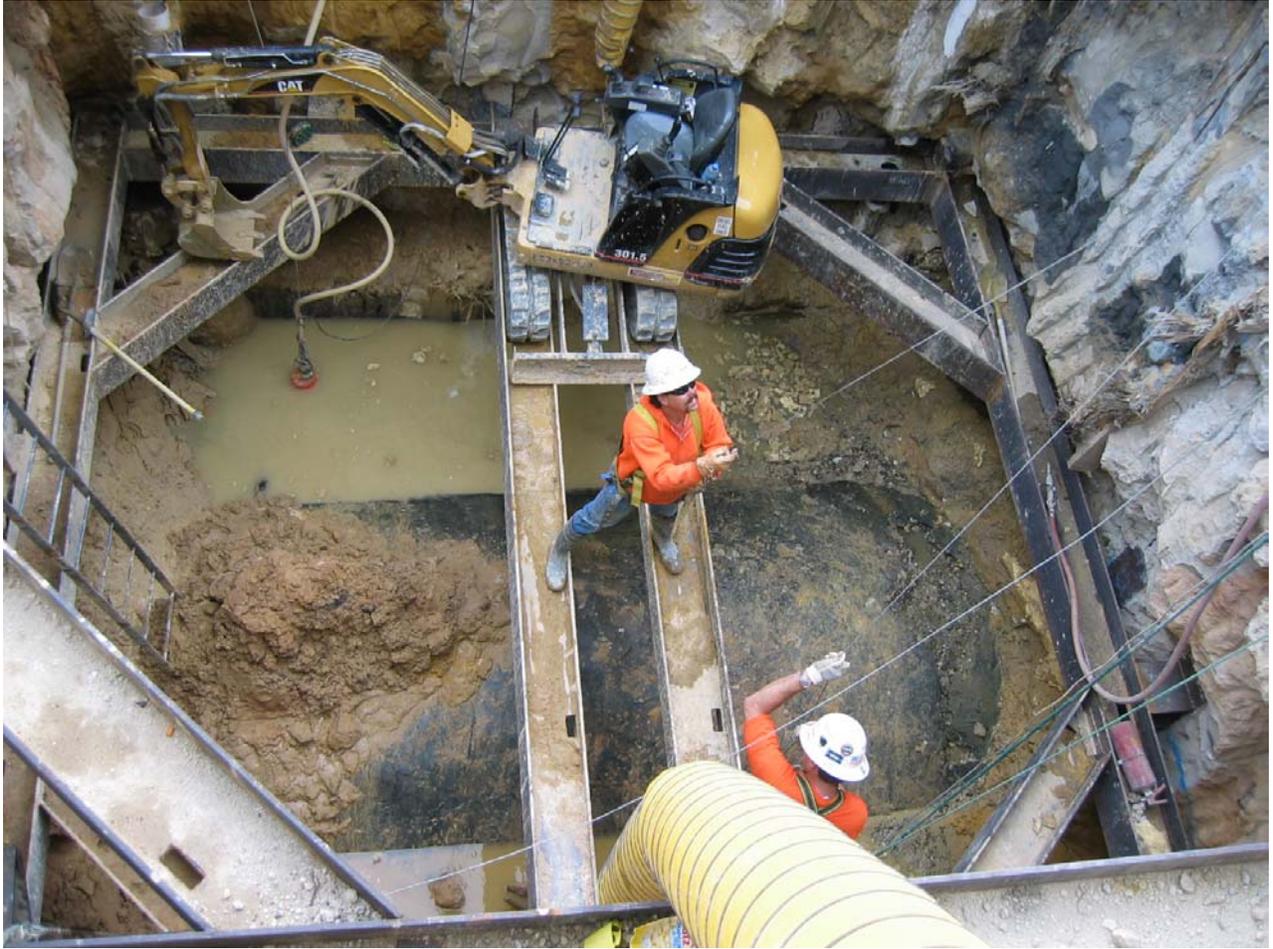
Figure 7 Photograph of Excavation showing exposed outfall, walers and jet grout walls

The photograph in Figure 7 shows the soil-crete and the lowest level of walers and braces as well as the excavation equipment.

Excavation safety was maintained throughout with heavy equipment working on steel platforms framed into the excavation support. All personnel were harnessed to a crane above the excavation prepared to haul them to safety if needed. Figure 7 also shows the dewatering pump and the means of excavation as well as some of the safety precautions taken at the site such as the tie-offs and the vent tube to supply fresh air. During the excavation, the wood shoring used during the original construction was exposed in the side of the excavation confirming that the tunnel was built using cut and cover methods.
