## Long-Distance Grouting, Materials and Methods Grouting Conference 2003

### Abstract

An abandoned 1600-meter (mile-long) rock tunnel had to be completely filled with grout. The total tunnel volume was approximately 4500 cubic meters (6000 cubic yards). The tunnel was water-filled with access only at each end through narrow, 25-meter deep (80 ft), vertical shafts. Access for pumping was feasible only from one end of the tunnel, thereby requiring unusually long distances for pumping.

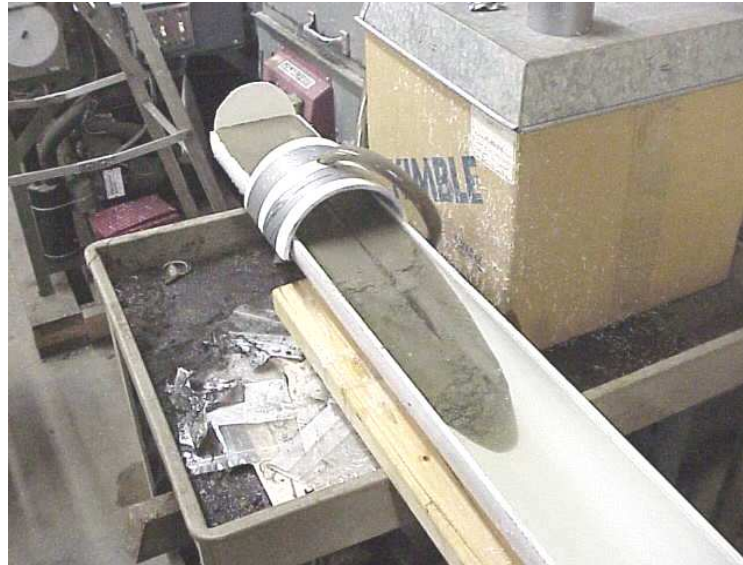
Figure 2. Model test of grout placement in a tunnel full of water

The second bench-scale test was devised to model the horizontal displacement of the water in the tunnel as the grout is placed. The setup was a half-pipe full of water with a grout tube inserted at one end. A long slope of grout pushing the water forward was expected. As the photo in Figure 2 shows, there was actually a surprisingly steep face of grout (1:5 vertical : horizontal) that formed. Again, there was essentially no mixing of the leading edge of the grout with the water.

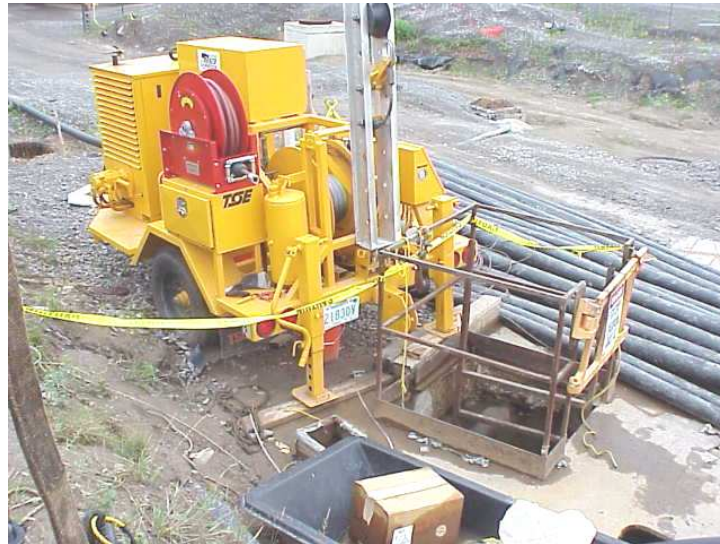
Figure 3. Pipe puller and shaft at the shore end of the project

Fabricated rollers were installed at the base of the access shafts to allow pipes and cables to be pulled through without damage. This was accomplished using divers. Next a small remote-operated vehicle went through the tunnel carrying a small diameter cable. This cable was used to pull through a larger cable that was about 3200 meters (10,000 ft) long. This cable was wound onto cable drive pipe pullers at both end of the tunnel so that it could travel back and forth through the tunnel, dragging in the many components of the grouting system. Considerable attention was paid to the details of cable connections to avoid the possibility of snagging on a previously placed component.

The cable was then rewound on the pipe puller at the shore and attached to the first and longest primary grout pipe that was then dragged through using the river-end pipe puller. This pipe reached all the way to the base of the river shaft and succeeding pipes were each about 300 m (1000 ft) shorter than the last. A total of five primary grout pipes would be placed, ranging in diameter from 150mm (6-inch) to 100mm (4-inch). To speed placement of the pipes, they were prefabricated into sections of approximately 150 meters (500 feet). Each pipe had a conical tip designed to keep out sediment as the pipe was dragged into the tunnel yet that would open when grout pressure was applied. An emergency sleeve valve was mounted a short distance back from the tip designed to provide an outlet in the event the tip was blocked.

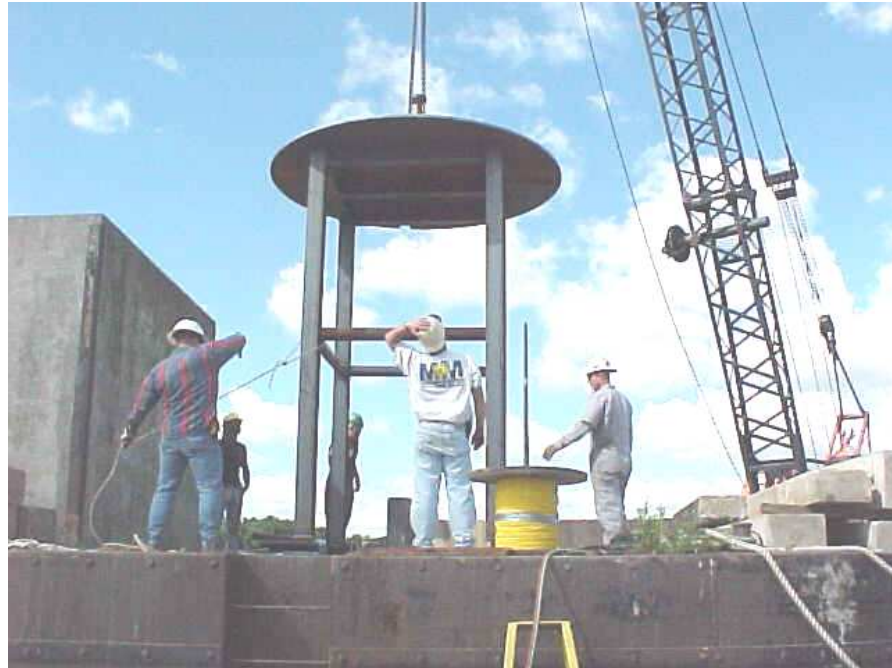
Figure 4. Placing the steel “stool” in the river shaft in preparation for the tremie seal

Once the pipes were all placed, it was time to block the river shaft so that grout would be forced back towards the shore once pumping started. This was accomplished by placing a steel “stool” in the shaft, sealing around the edges and pouring tremie concrete on top of the structure to seal the shaft. After this was done, the only grout pipe left accessible from both ends was the secondary grout pipe.

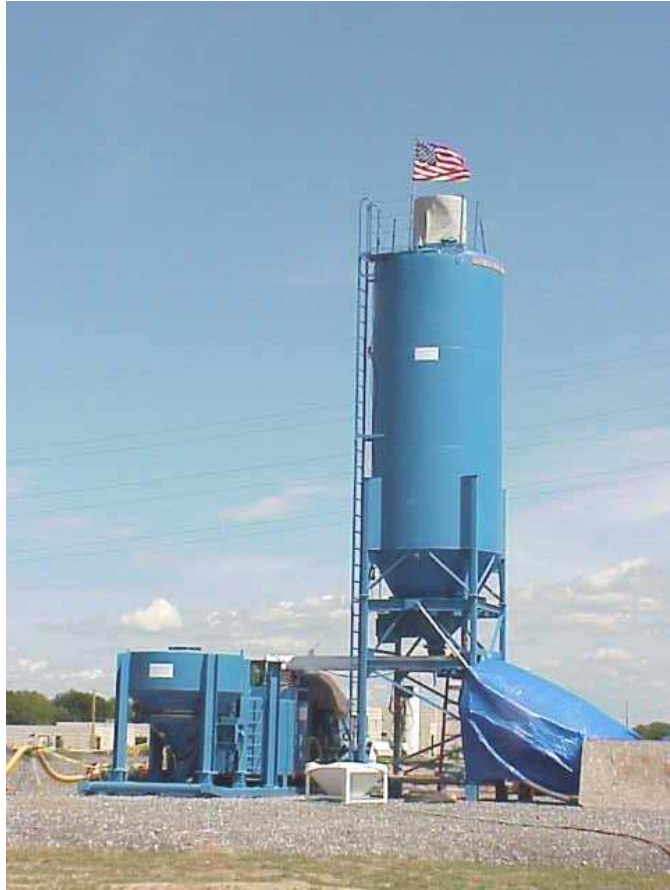
Figure 5. Grout mixing plant

The one-component mixing system was crucial to the project design since it would allow for a continuous as opposed to a batch mixing system. The mix plant consisted of a 4.5 cubic meter (6 cubic yard) capacity colloidal enclosed mixer fed by a variable flow liquid system and a variable speed dry material feed system. The level in the mixer was controlled by a sonar device; feed rates of the materials were adjusted based on real time continuous density measurements provided by a highly accurate coriolis density meter. Slurry was pumped in a rate sufficient to keep the level in the mixer constant as the material was pumped out and the rate of feed for the cement blend was controlled based on density.

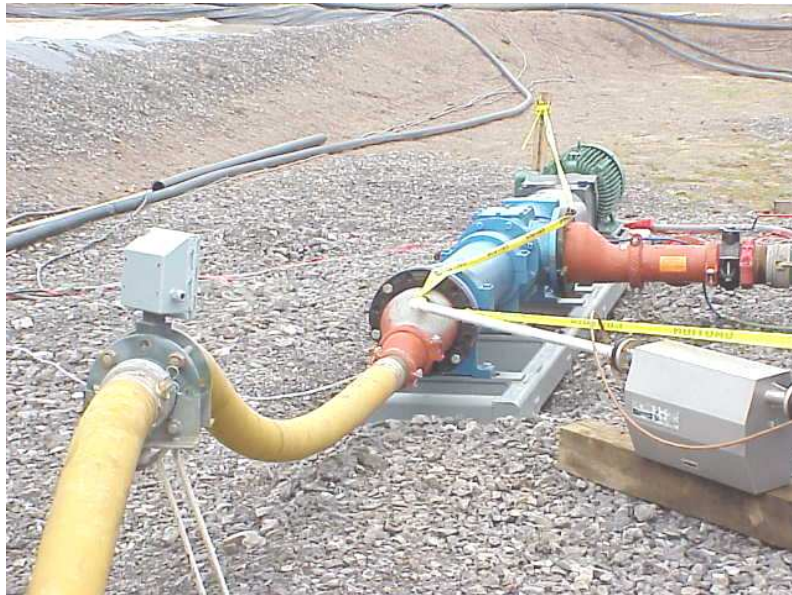
Figures 6. Pumping unit with density meter to the right and flow meter to the left.

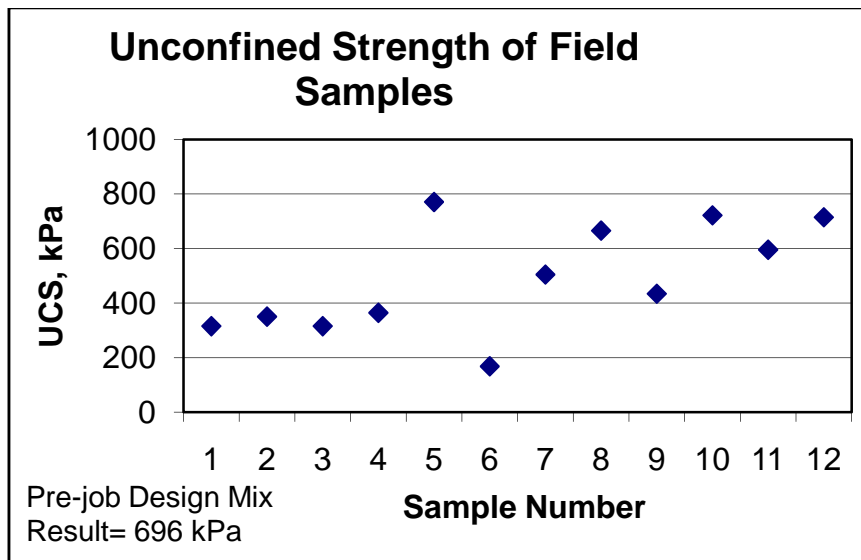
Figure 7. Unconfined strength of samples taken during the work

Throughout the grouting operation, samples of the grout mixture were collected for strength and permeability testing. The results, Shown in Figures 7 and 8, show that the quality of the grout consistently met the project objectives of greater than 100 kPa unconfined strength and less than  $1 \times 10^{-6}$  cm/sec permeability after 28 days of cure.

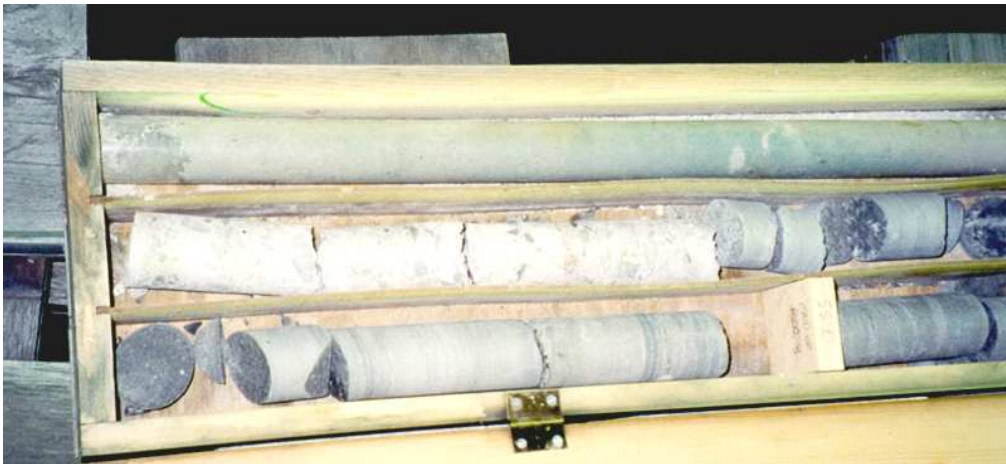
Figure 9. Confirmatory drilling core showing, from the top, grout from the tunnel, the concrete tunnel floor and bedrock.

When the barge was close, one spud of the barge was sunk into the riverbed while a tug was used to rotate the barge to achieve the final location. Both of the borings in the river confirmed a complete fill with competent grout. The core in the upper part of Figure 9 (encased in a Lexan<sup>®</sup> sleeve) shows the integrity of the grout; in color, the grout is the green-black color that is typical of BFSB-based grouts. The cores in the lower part of the figure are samples of the concrete tunnel wall and the bedrock.
