CONSTRUCTION OF A SELF-HARDENING SLURRY CUTOFF WALL AT TAYLORSVILLE DAM, OHIO

ABSTRACT

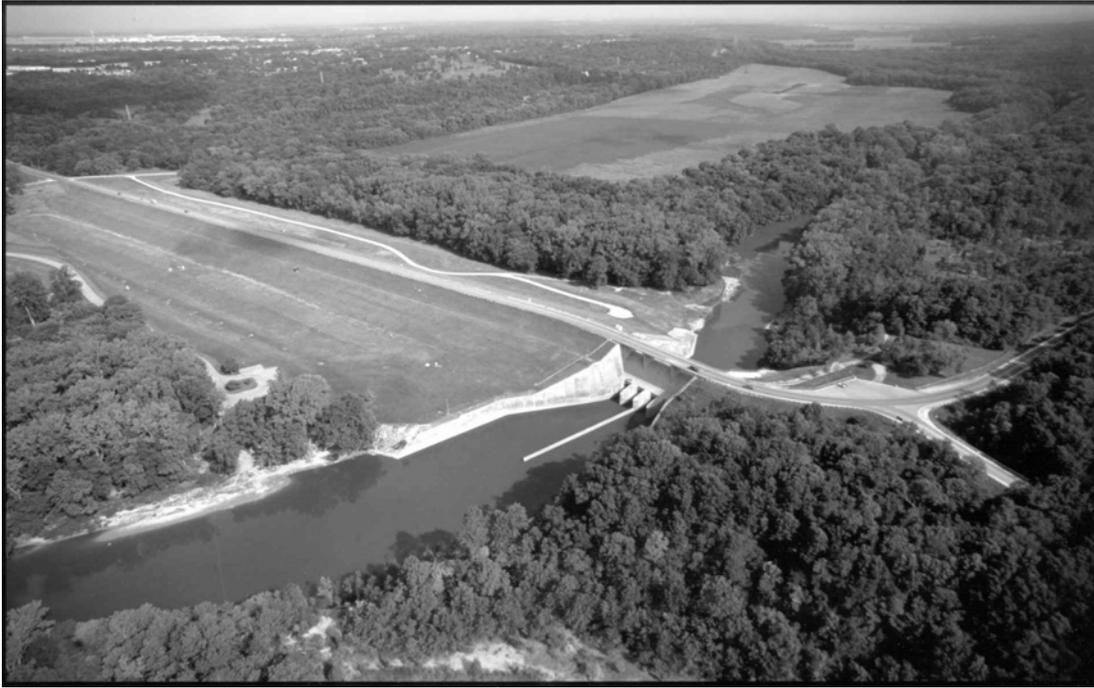
Figure 1. Aerial Photo of Taylorville Dam

Taylorville Dam is located near the City of Vandalia, Ohio and is an earthen embankment located across the Great Miami River. U.S. Route 40 is located along the crest of the dam. The Miami Conservancy District (MCD) built the system of 5 dams, and associated levees for flood control only; therefore the dams do not include gates or permanent reservoirs.

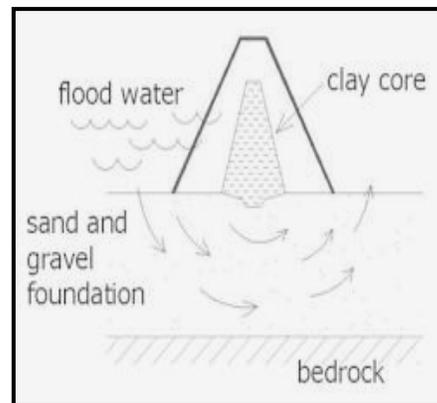
Figure 2. Dam Schematic

- The installation of additional relief wells into the underlying sand at the downstream base of the dams,
- Increasing the size of the toe berm at the downstream base of the dams, and
- Raising the dam cut-off from the existing clay core up to the top of embankment by installing a low-permeability slurry cut-off wall at the top of the earthen dams.

All three of these remedies were required at Taylorsville Dam. The Dam Safety Initiative is the MCD's largest investment in the flood protection system since the original construction in 1918-1922. The various improvements are discussed below.

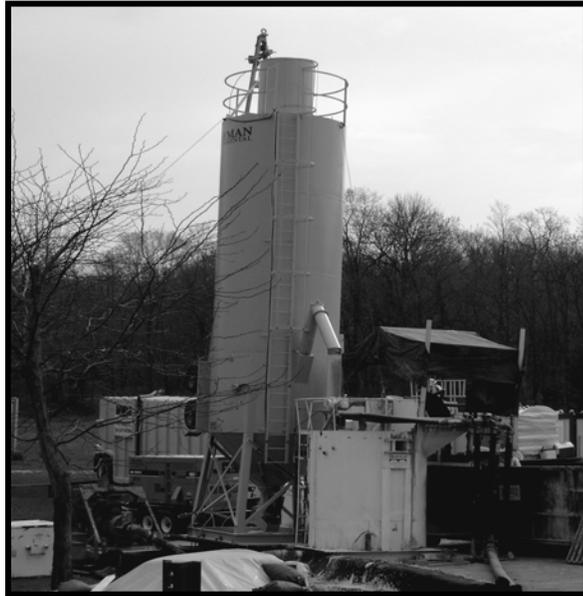
Figure 3. Slurry Batch Mixing Plant

At the Taylorsville project, the bentonite slurry was prepared using a jet-shear mixer and several 21,000 holding tanks for storage and hydration. Storage ponds are preferable, if site conditions will permit.

Once the bentonite slurry is hydrated adequately and meets the required quality control testing values, the slurry is delivered to another mixing tank for addition of the GBFS and cement. The slag is transferred from the storage silo to the mixing tank using a metered auger for consistent proportioning. The slag-cement-bentonite slurry is then pumped to the trench through 4 and/or 6" high-density polyethylene piping to the trench, up to thousands of feet.

Mix quality was controlled using premeasured bentonite jumbo bags and 94# bags of Portland cement; water meters on the fresh water and bentonite slurry; and a weigh scale for the slag. These measures allow complete control of the mix by weight. Density of the mix was periodically checked, as well.

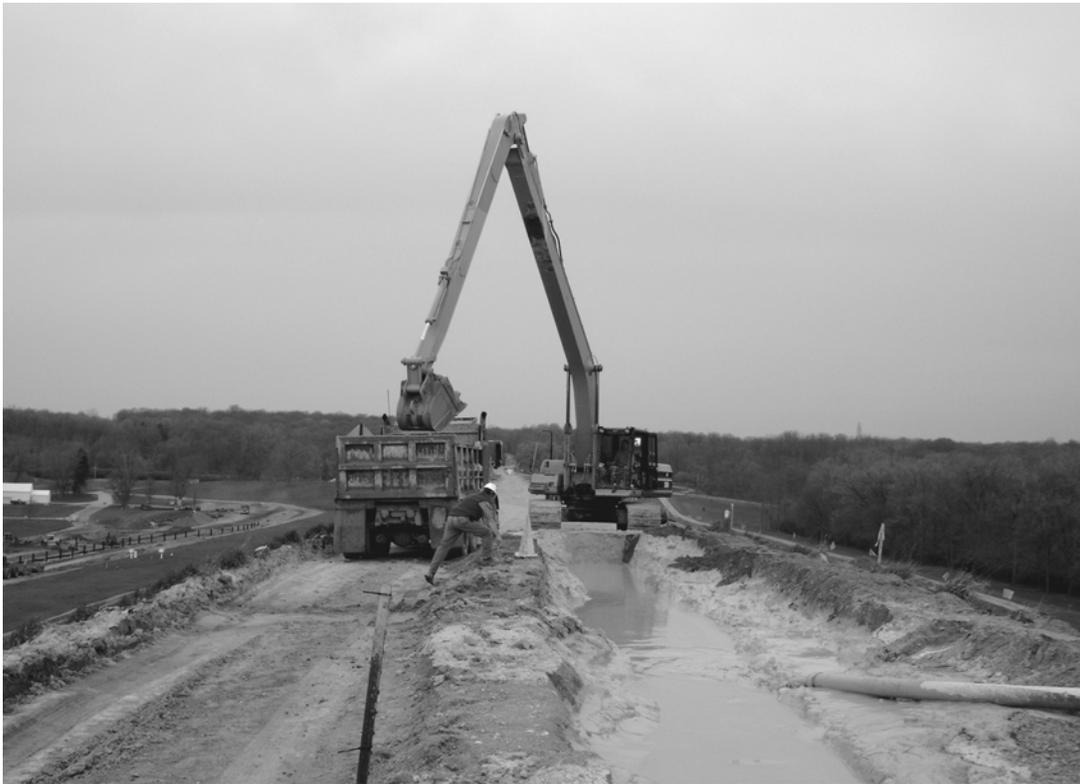
Figure 4. Slurry Wall Excavation with Relief Well Installation Downgradient (left)

Trench Excavation: The trench was excavated with a CAT 330 excavator equipped with an extended boom and stick. The arrangement had a maximum depth capacity of 45 feet below ground surface which was required for the wall installation which ranged from 28 to 40 feet deep. As the trench was excavated, slurry was pumped into the excavation and maintained within several feet of the workpad surface.

During trench excavation, small earthen berms were placed along both sides of the trench to contain the slurry within the limits of the trench. These berms were constructed out of dry trench spoils removed from the top several feet of the trench and were then ultimately used as capping material as the trench was backfilled back to the ground surface.
