SOIL NAIL AND JET GROUTED EXCAVATION SUPPORT WALL AT PEIRCE MILL DAM

As part of the Woodrow Wilson Replacement Bridge project several damaged wetland and environmental areas were to be mitigated. One of the mitigation projects consisted of constructing a Denil fish ladder around Peirce Mill Dam in Rock Creek National Park, Washington, D.C. The dam is a historic structure operated by the National Park Service. The fish ladder is located between the east abutment of the dam and Beach Drive, a major collector road. Construction of the fish ladder required removal of a portion of the east abutment and an excavation that extended about 22-ft below the pavement of Beach Ave. It was not possible to close Beach Drive except for very brief intervals or at night; therefore, a support of excavation system that would minimize disruption to the public was required. The high groundwater required that the groundwater be cut off prior to excavation; the random rubble and soil fill, and shallow but erratic rock surface precluded driving sheet piling. A jet grout system was selected because the grout probe could penetrate the rubble fill, stabilize a variety of soil conditions, and cut off the grou

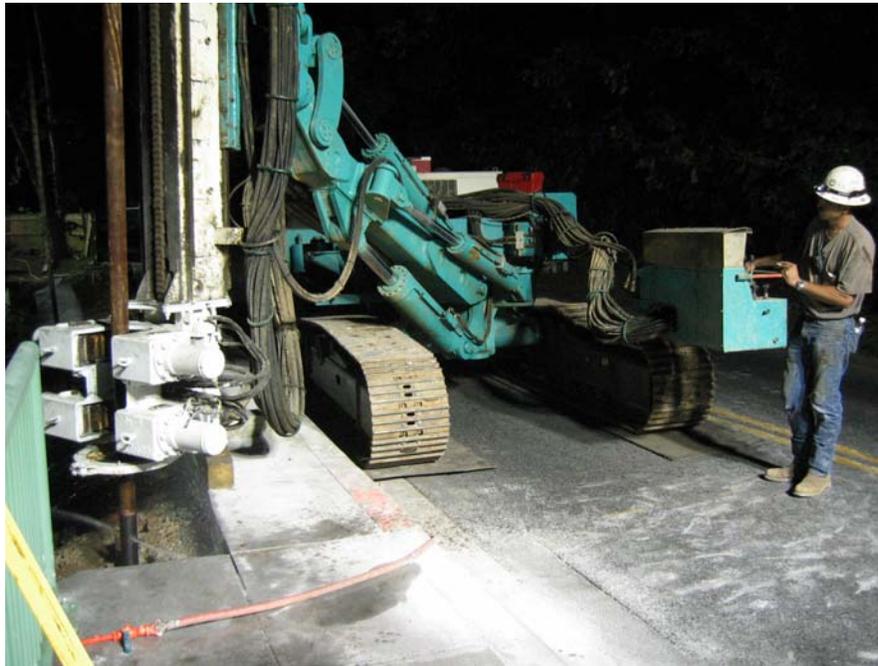
Figure 8 - Jet Grout Installation from Beach Drive Showing Water Jets, Operator and Protective Mats

A total of 59 columns were installed to drilled depths ranging from 11 to 21-ft and the grouted length ranging from 2 to 21-ft. Fractured rock was grouted at the bottom of some of the columns during initial jetting operations. The grout columns were about 3-ft in diameter. A photograph of an excavated test column is shown in Figure 6. Figure 7 is a photograph of the jet grout rig installing a jet grout column.

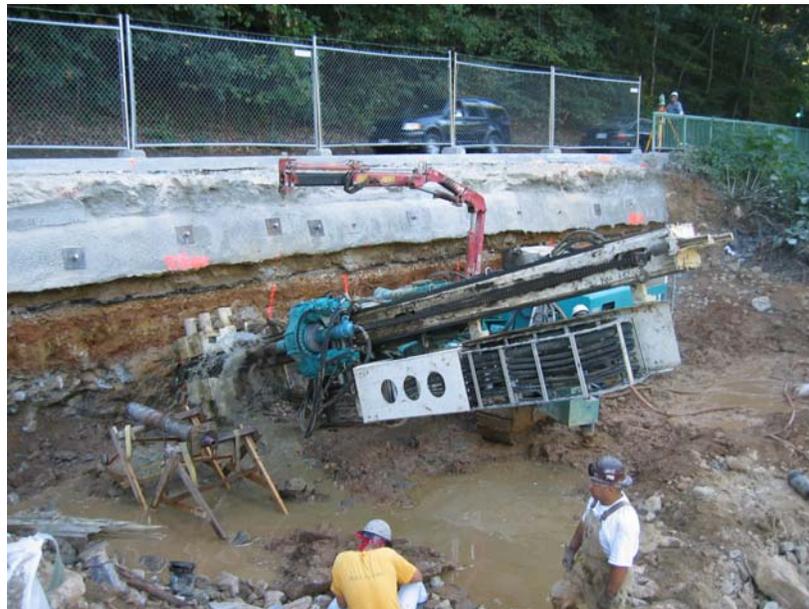
Figure 9 - Soil Nail Installation Showing Old Pavements, Rubble and Soil Fill

The working area was confined to a narrow strip limited by the temporary coffer dam and Beach Drive. This is illustrated in Figures 9 through 11. The equipment could not turn, it had to drive straight in and back out. The grout batch plant and staging area was the parking lot north of the proposed fishway.

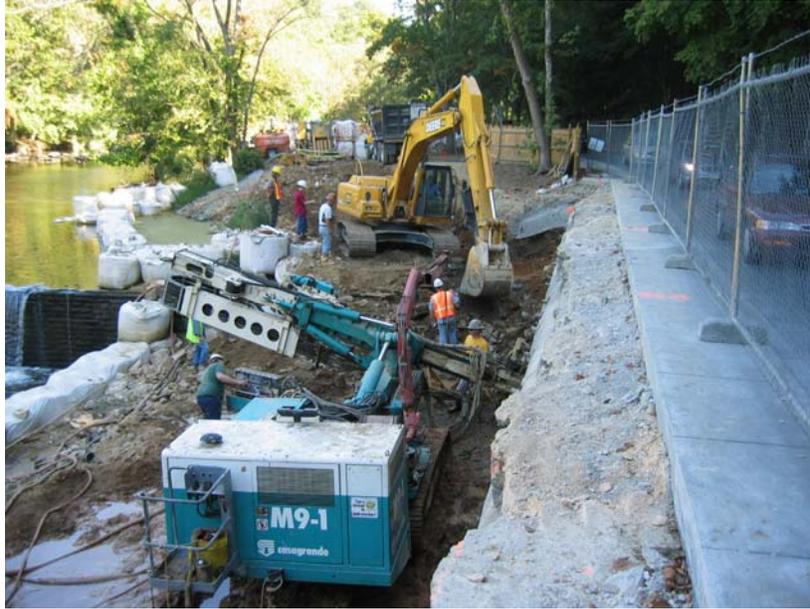
Figure 10 - Soil Nail Installation Showing Proximity of Peirce Mill Dam, Temporary Cofferd Dam and Beach Drive

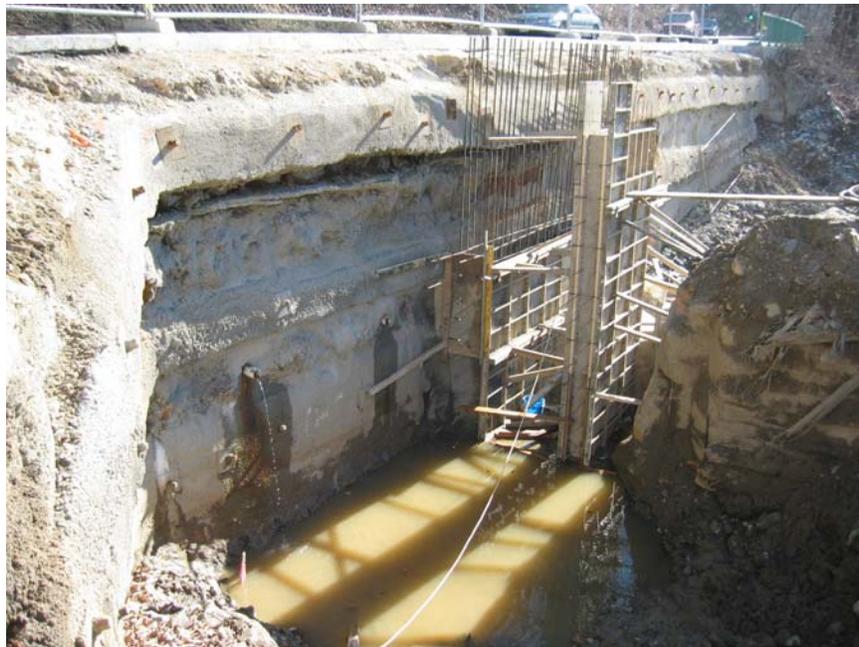
Figure 11 - Finished Soil Nail Wall Showing Weep Holes, the East Abutment of Peirce Mill Dam and the Formwork for the Fishway.

The weep holes shown in Figure 11 flowed continuously illustrating the need that a stable
