## Successful Remediation of Solvent-Contaminated Groundwater Using a Funnel and Gate Constructed by Slurry Trench Methods

Steven R. Day<sup>1</sup>, Jeremy Porter<sup>2</sup>, Barry Kellems, P.E.<sup>2</sup>, and Doug Hillman, P.G.<sup>2</sup>

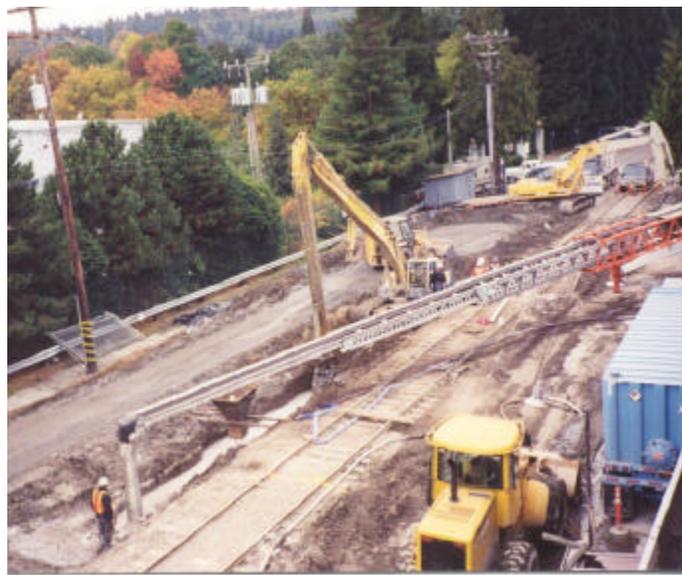
Using the results of the bench test, the designers devised a layout for the funnel and gate. The design had to recognize the constraints of the site and the effect on construction, as well as on the final development of the site. A 330-foot-long funnel and gate, consisting of three CB cutoff walls (funnels) and two 45-foot-long permeable reactive gates, was designed to capture and treat the chlorinated solvent plume. The 3-foot wide gates were designed with a 50/50 mixture of iron filings and sand. The gates were designed to be constructed using biodegradable, guar-based slurry, which avoided the need to drive sheet piling saving significant cost. The barrier was imbedded three feet into the dense, impermeable till layer to prevent underflow.
